## **LIMITED ASBESTOS & LEAD PAINT INSPECTION REPORT**

Ballardvale Fire Station  
1 Clark Street  
Andover, Massachusetts

**Hillmann Project No. M3-2719**

April 23, 2014

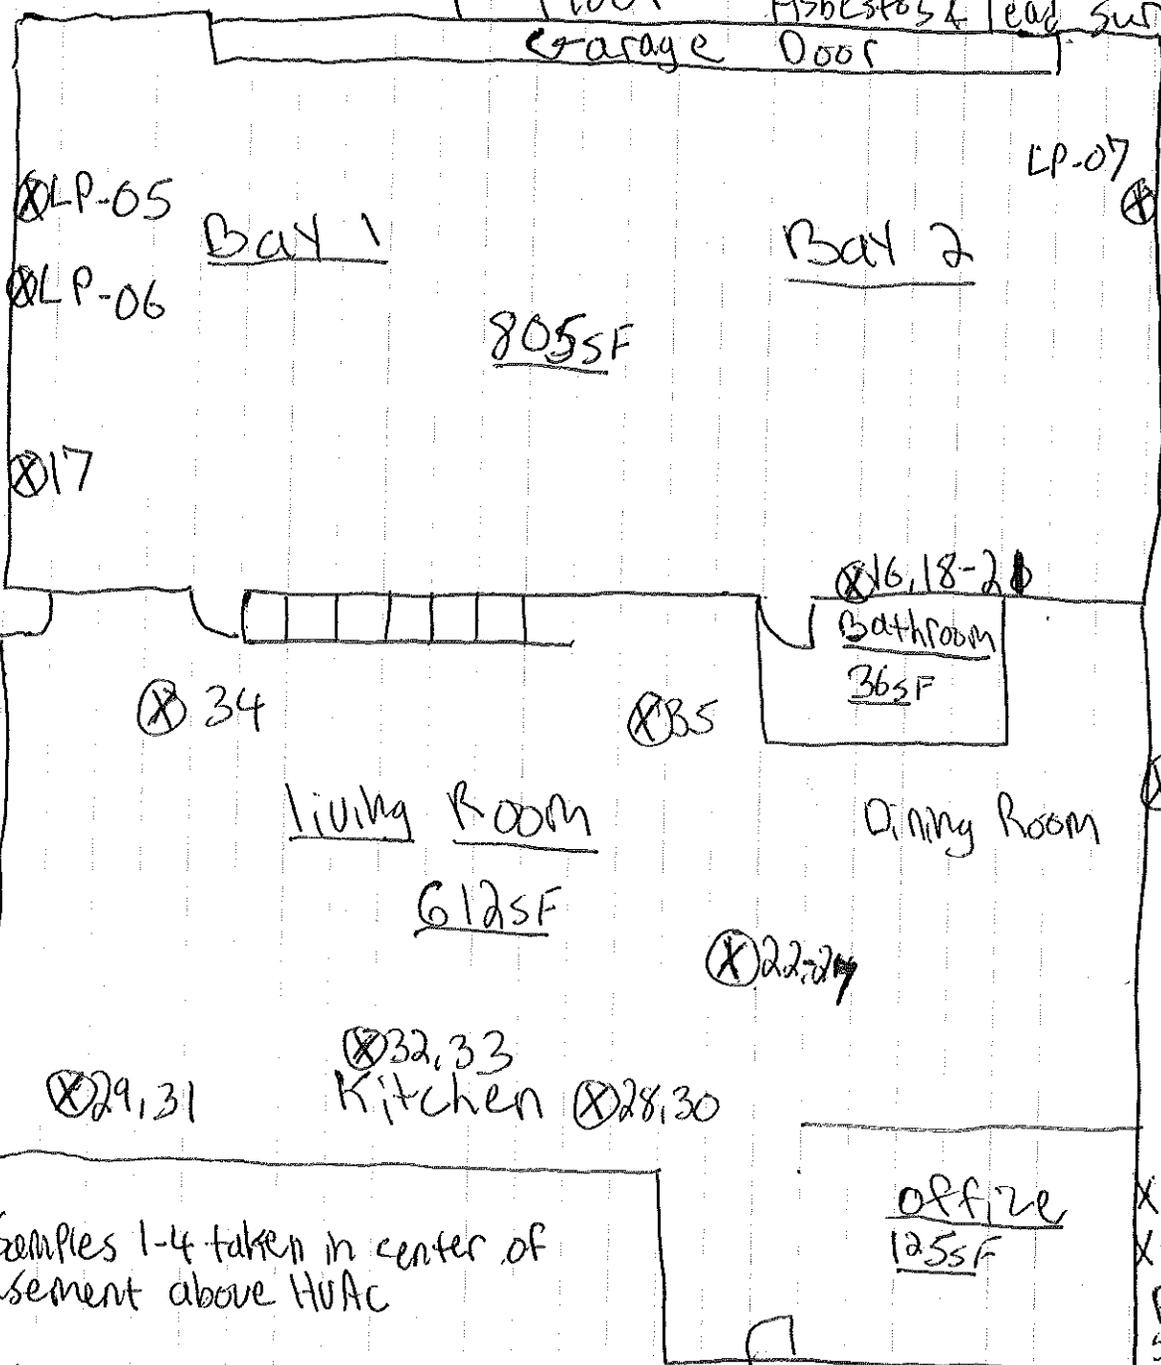
Asbestos & Lead Survey

+ Samples 1-4 taken in center of basement above HVAC

+ Exterior wood shingles with layer of tar paper beneath.  
- 3 layers of shingles
