HAZARDOUS MATERIALS SURVEY
Former Andover DPW Yard
11 Lewis Street
Andover, Massachusetts

September 2019

Project 17487

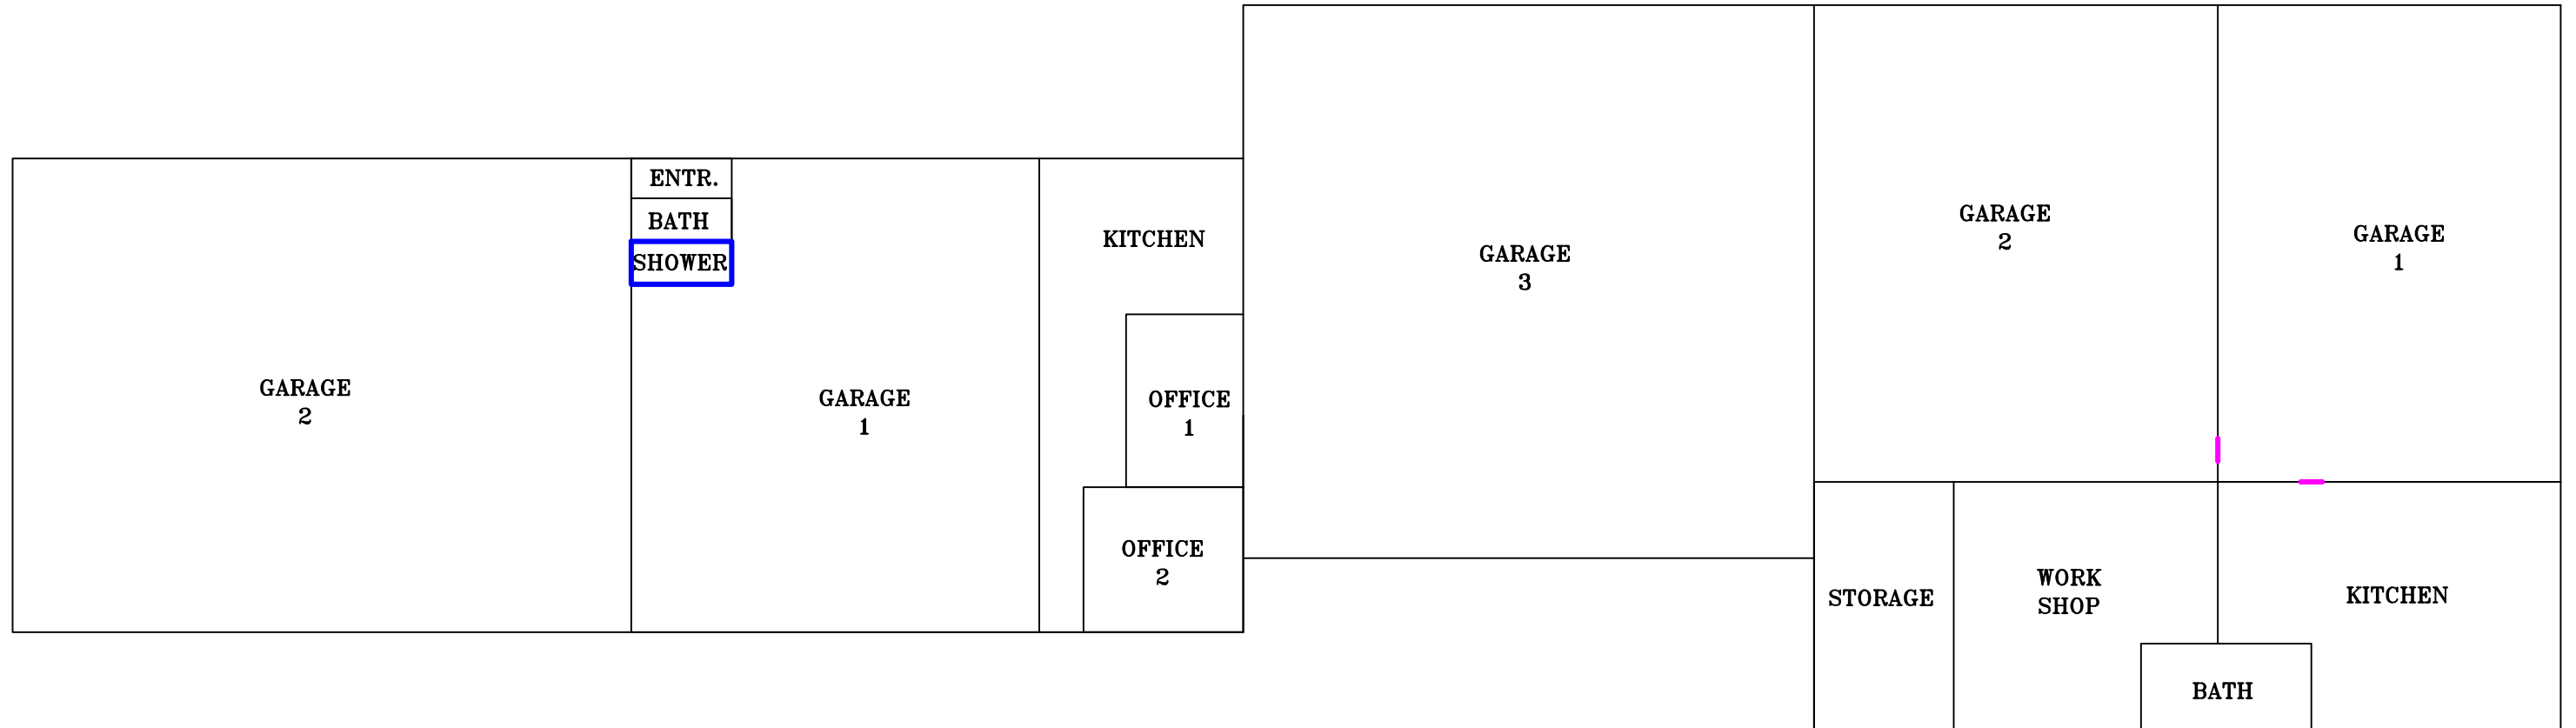
FIGURE: 1
PROJECT NO:17487
DATE: SEPT 2019

- Rectangle Pattern Sheet Floor
- Door Caulking

— APPROXIMATE LOCATION OF ASBESTOS-CONTAINING
RECTANGLE PATTERN SHEET FLOOR

— APPROXIMATE LOCATION OF ASBESTOS-CONTAINING
DOOR CAULKING

Asbestos was positively identified at the 11 Lewis Street buildings, as summarized in **Section 2** and **Appendix D**. In accordance with NESHAP and DEP regulations, all friable ACM, or materials made friable by demolition or renovation activities, must be removed from the building by a licensed asbestos abatement contractor, prior to demolition or renovation. Removal of ACM is regulated by MassDEP and DLS. GREEN recommends the identified ACMs be removed from the buildings in accordance with applicable asbestos abatement regulations prior to the start of planned renovation activities. Asbestos abatement must be done by a Massachusetts licensed Asbestos Abatement Contractor and be properly disposed of off-site at an appropriate receiving facility in compliance with all applicable state and federal regulations. The Massachusetts asbestos regulations require a visual inspection and clearance air monitoring at the completion of an asbestos abatement project. Full-time project monitoring activities during asbestos abatement activities to ensure compliance with design specifications and regulations is recommended.

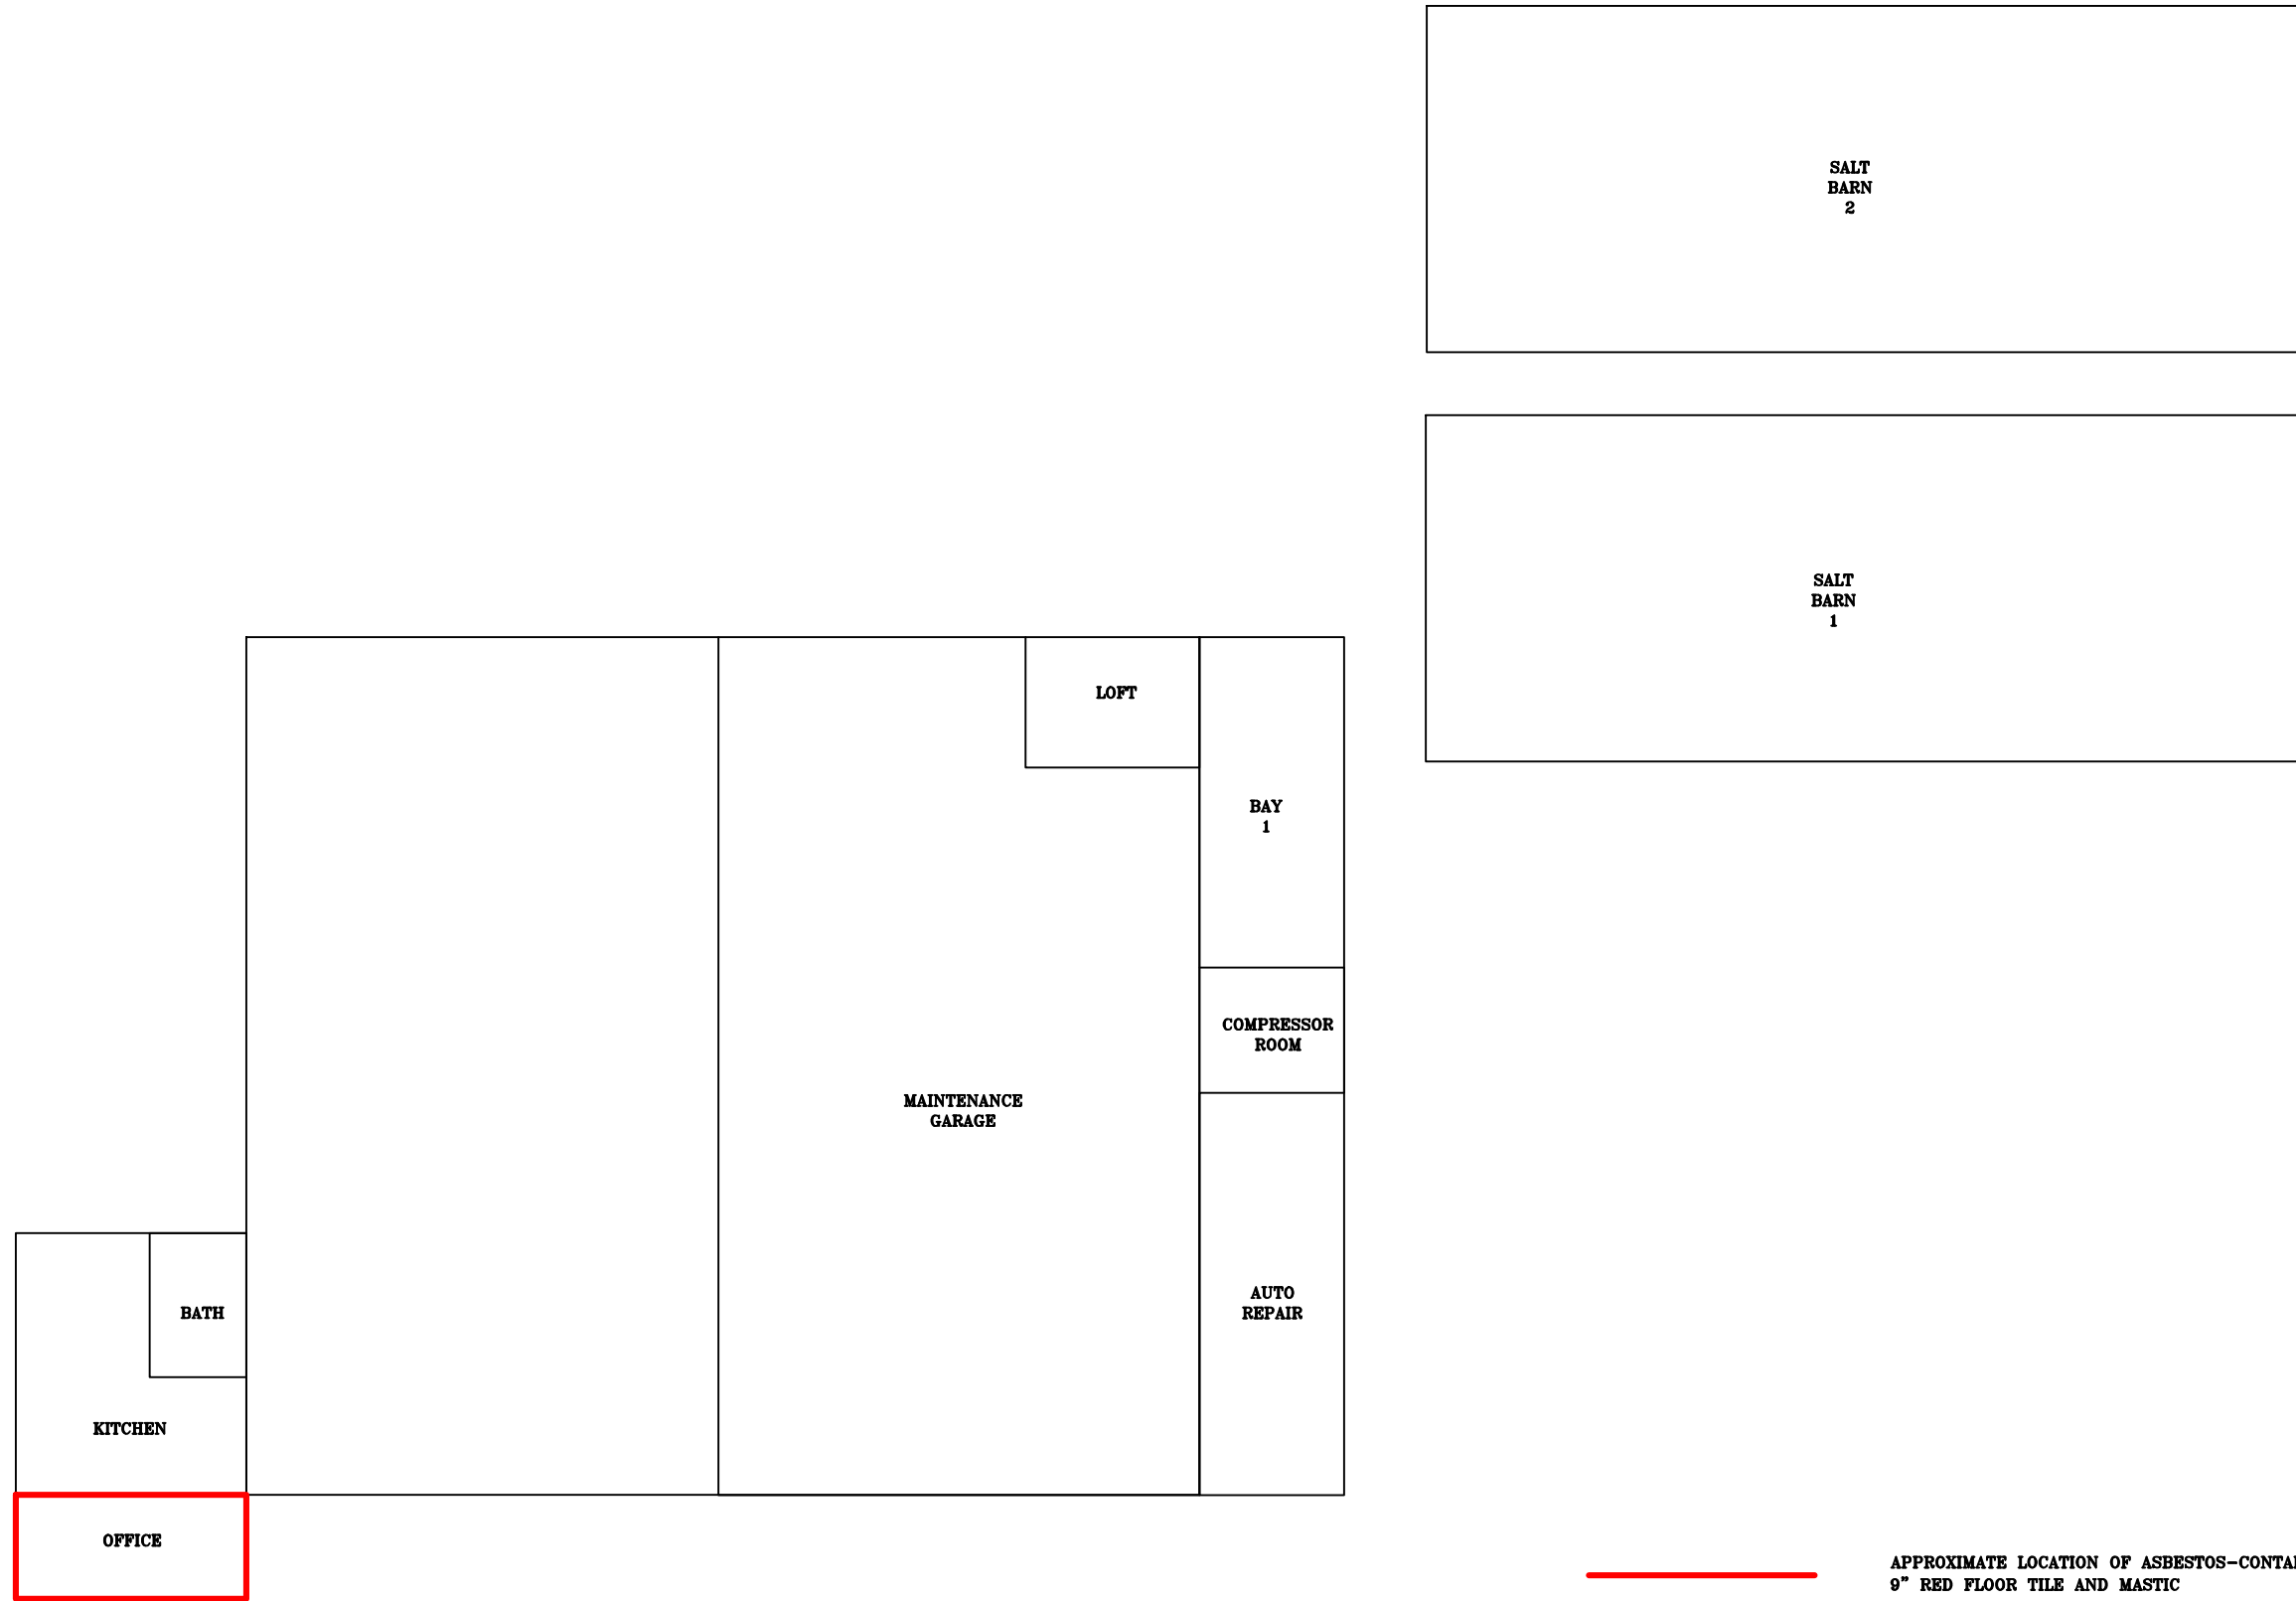
FIGURE: 2
PROJECT NO:17487
DATE: SEPT 2019

- 9" Red Floor Tile
- 9" Red Floor Tile Black Mastic

APPROXIMATE LOCATION OF ASBESTOS-CONTAINING
9" RED FLOOR TILE AND MASTIC

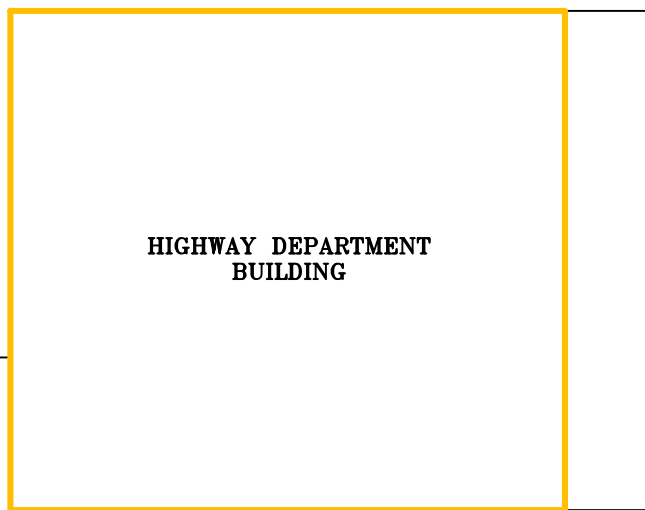
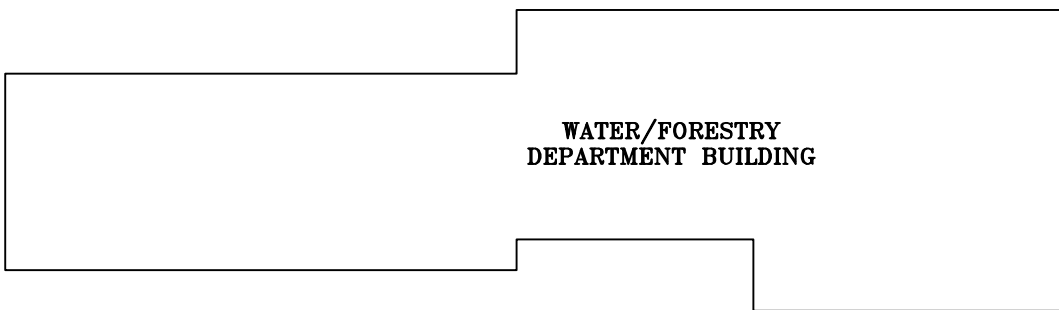
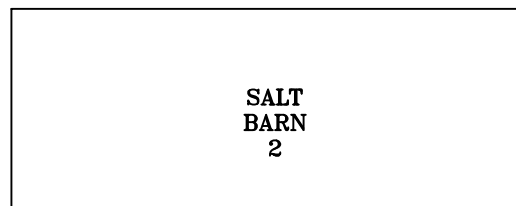
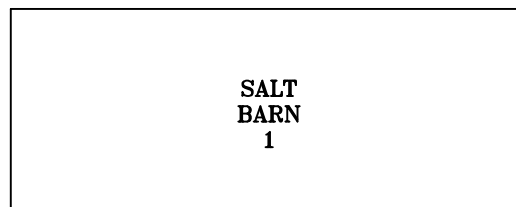
FIGURE: 3
PROJECT NO.: 17487
DATE: SEPT. 2019

ASBESTOS-CONTAINING FIELD FLASH MATERIAL

TRACE (<1%) ASBESTOS-CONTAINING BLACK COATING ON METAL DECK

NOTE: Materials containing trace amounts (less than 1%) of asbestos are not fully regulated as an ACM in Massachusetts, however, they must still be handled in accordance with OSHA 1926.1101 and per current DEP regulations, must be disposed of under an asbestos waste shipment record as asbestos-containing waste material.

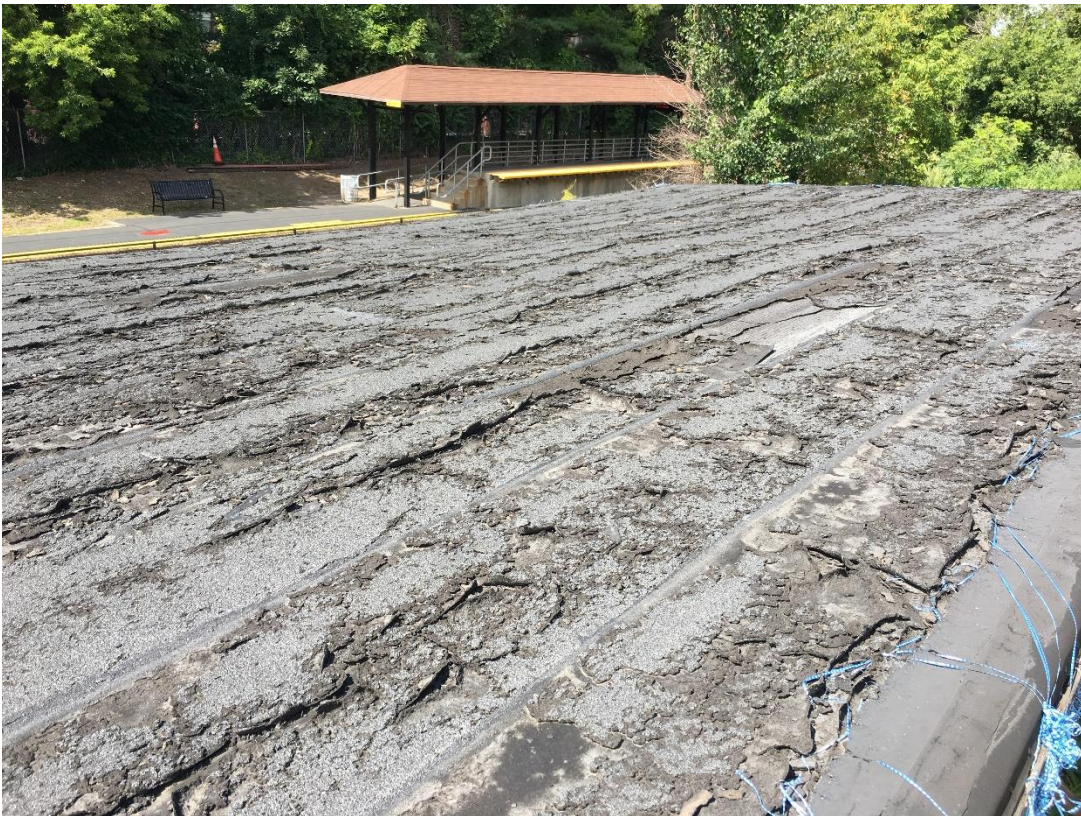
- Field/Flash Material

A representative view of the asbestos-containing roof material on the shed
