## **Review for Inclusive Design of City of Andover Rail Trail at Haggetts Pond**

September 22, 2016

January 2, 2017

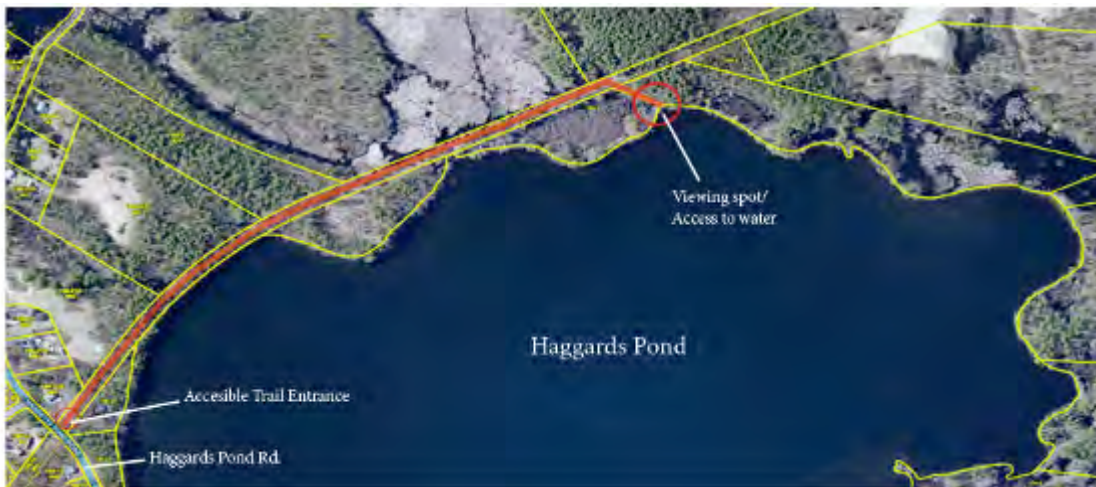
(The red line indicated the path taken on the review of the Rail Trail)

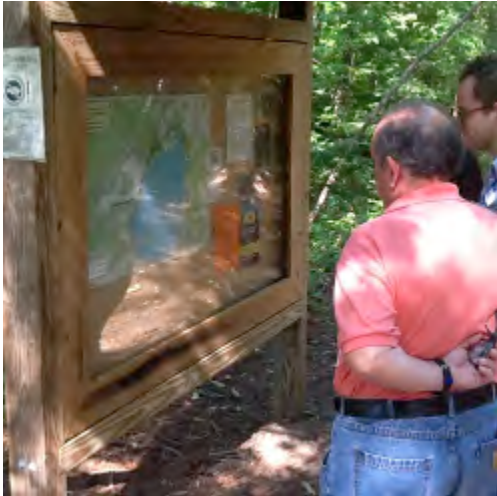
There are no compliance standards for waysides but the wayside would be considered a “program” of the Town and should be accessible. That would require attention to an accessible approach to the wayside, to the height of the wayside and the information within it and to the design of that information.

Existing wayside.

This would be a great opportunity to create a map to indicate the location of the accessible entrances to the trail, the location of restrooms, location of benches, and also indicating the slopes of particular paths to warn people who may have trouble accessing those paths.

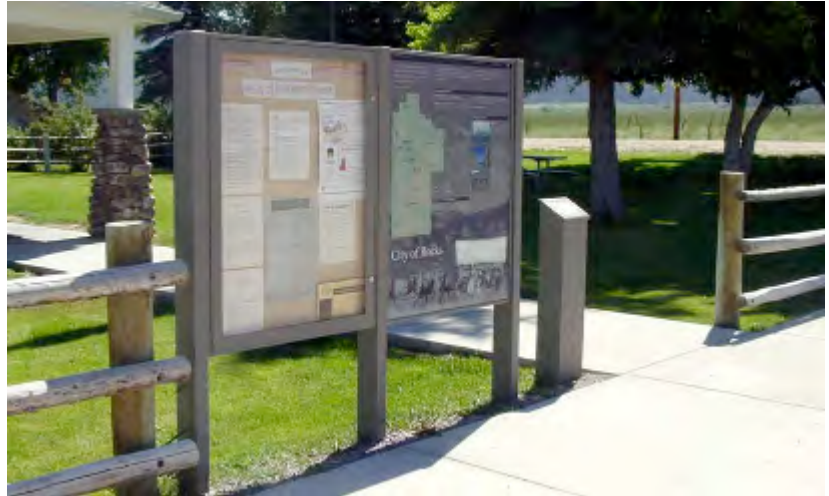
36 x 48 upright orientation bulletin case, and brochure dispenser, City of Rocks National Reserve

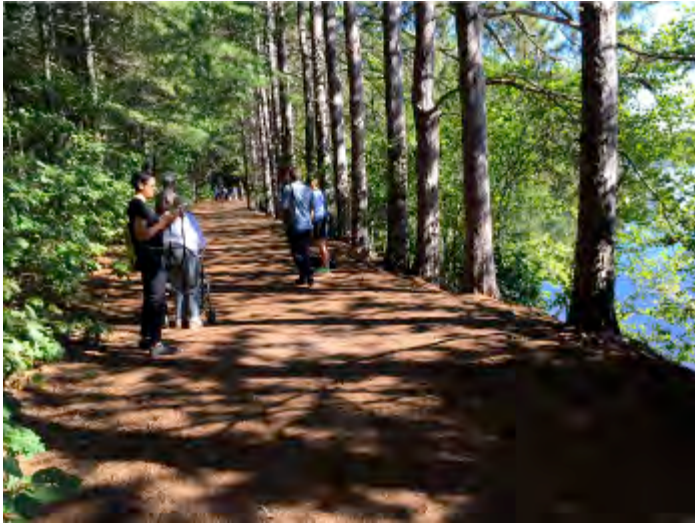
There is a limited area along the trail where the edge of the path drops steeply to the pond with no protection or barrier between the path and the water. To ensure safety, add a cane-detectable barrier, whether it be logs or large rocks or logs firmly lodged along that edge.

There is no indicator of the steep slope to the Pond in this one area.

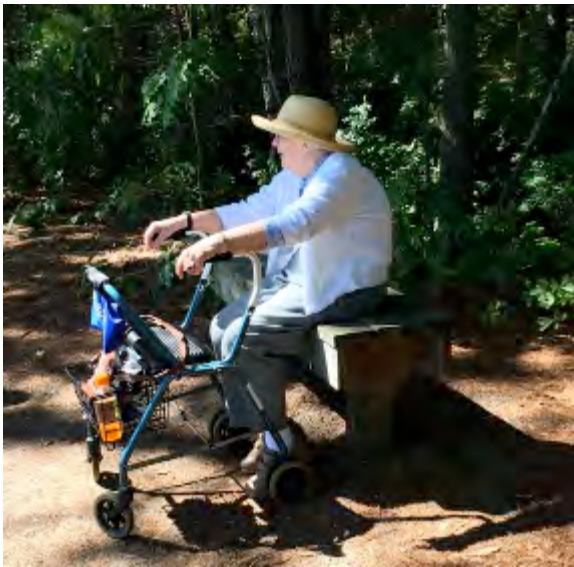
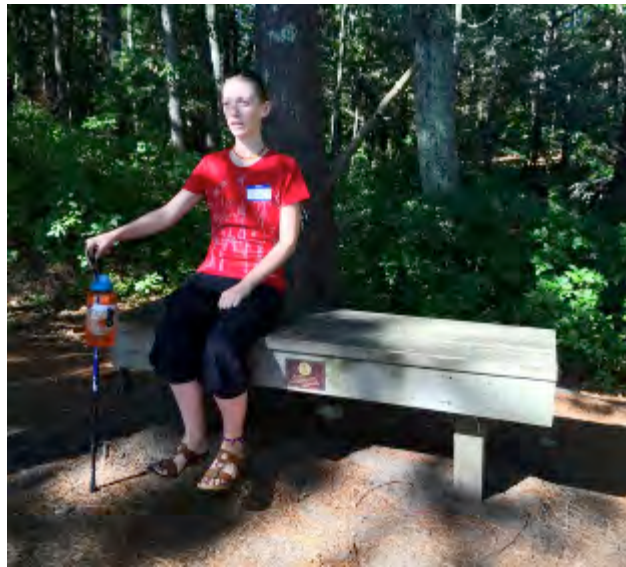
This is a significant determinant to welcoming many visitors. There were benches along the trail but too few were designed for easy use by anyone with a limitation. None were designed to make it

possible for a person using a wheelchair to sit adjacent to a bench or to transfer. A mix of benches, some with backs and arms, and individual seats could unobtrusively support more visitors with physical limitations from kids with mobility issues to older adults with mobility, strength and stamina issues. User/experts expressed frustration with the existing benches. A mix of issues compromised their usability including height that increased because of hollowing out of the ground below, flat uncomfortable surfaces and no backs or arms. Even well-placed rocks or logs can serve as informal seats especially for kids and those with stamina or breathing limitations.

Bench with no back support and eroding ground surface beneath.

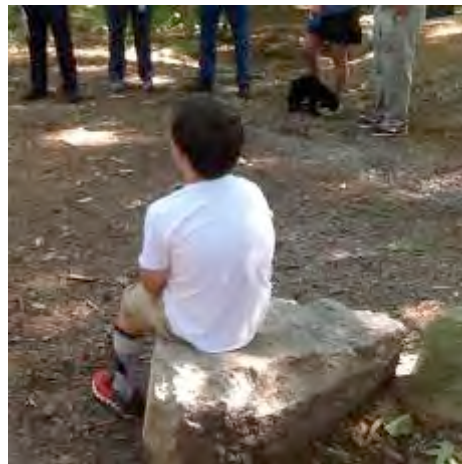
This boulder is working well as a casual seat.

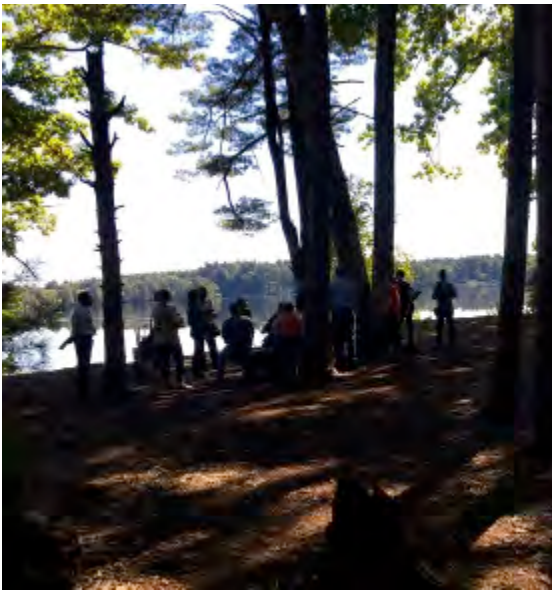
Viewing spot of the pond with one bench.

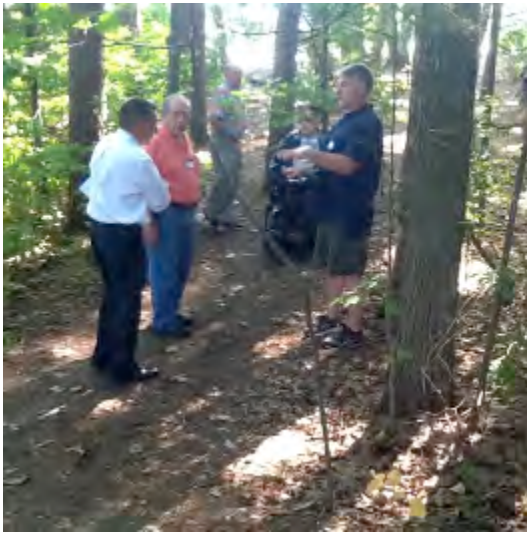
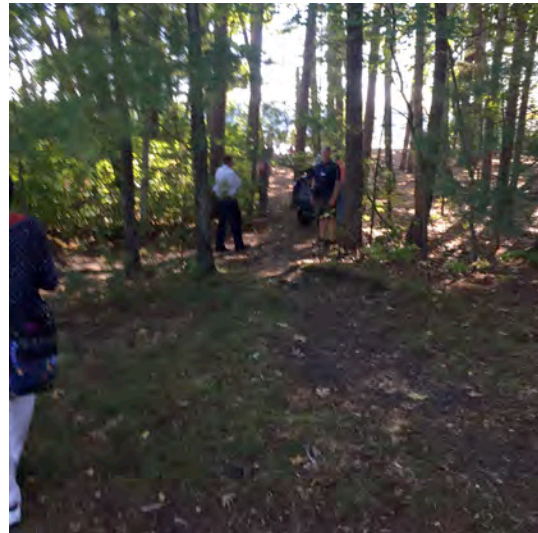
In addition to the natural steep slope of the land from the rail trail to this area, there were extensive tree routes. Locating an ideal approach and installing a sloped wooden walkway would mitigate the inevitability of the tree root problem recurring annually and make it clear that there is a path into the area. Note that there are already precedents on the other side of the trails for wooden walkways with railings. There are not fully accessible but do represent a precedent for a simple wooden structure in the same public space.

Slope with root intrusions on the route to the picnic area.

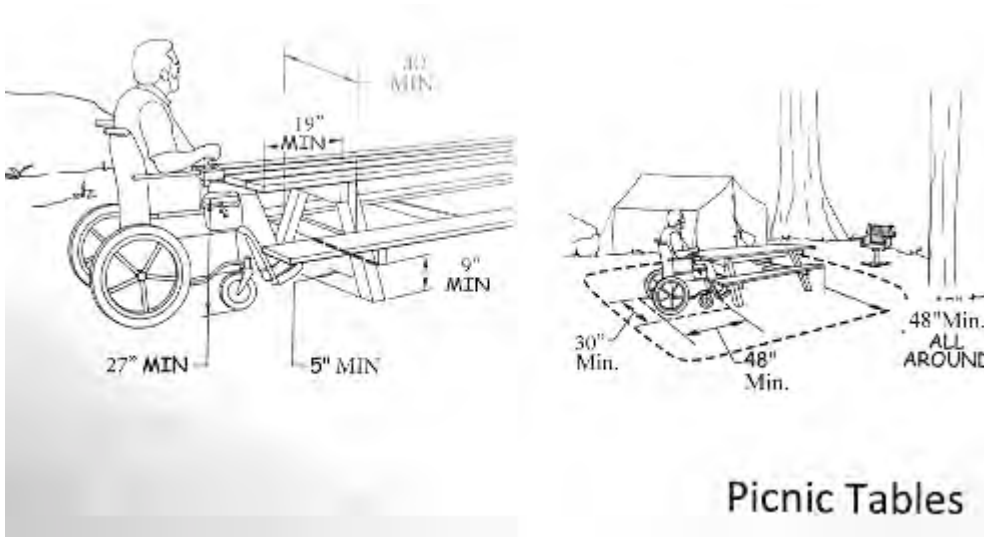
This area would need a number of picnic tables accessible from a stable path of travel and accessible for people using wheelchairs. See drawing detail:

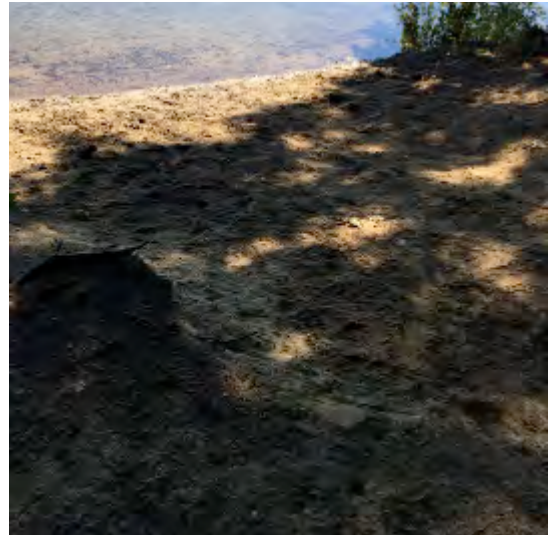
Viewing spot with the steep sloped path.

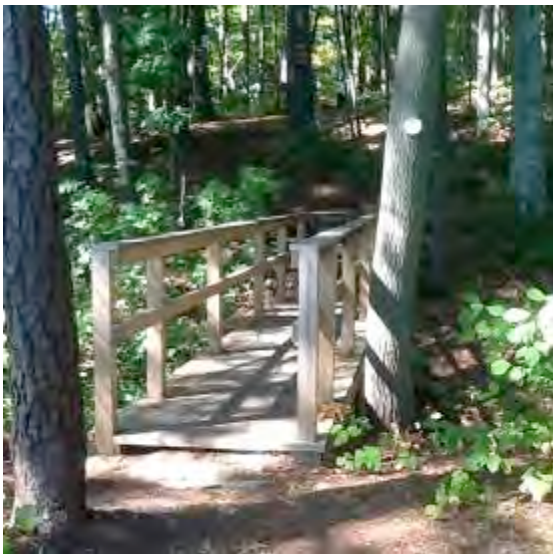
This bridge is on the opposite side of the trail heading into the woods and away from the Pond. It is not currently compliant but has small, correctable issues. Since it is already part of the visual vocabulary of the Pond, it is a model that should be considered for bridging the steep slope to the suggested picnic area and is easy to visualize as the basic outline of a fishing platform.
